2.0 FARM OPERATION AND PROPANE SYSTEM

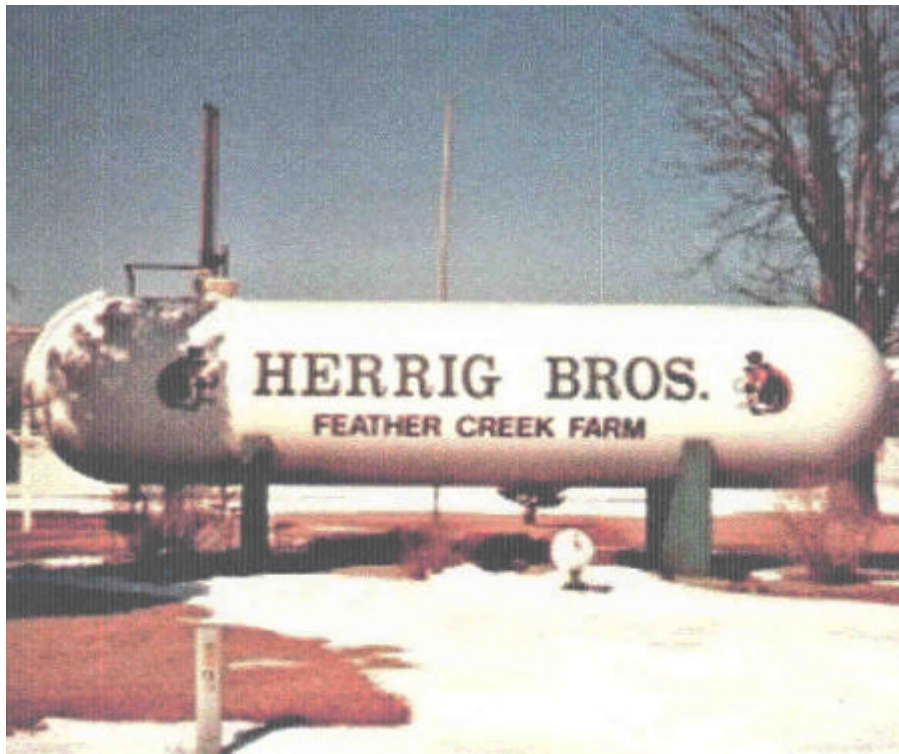
Figure 3. The 18,000-gallon Propane Tank That Exploded

The propane tank, which was made of carbon steel, was approximately 42 feet long and 9 feet in diameter. It was located approximately 78 feet north of the 490th Street centerline (see Figure 2, item 6). The tank rested on two concrete saddles with the bottom of the tank located approximately 4 feet above ground level. Figure 3 is a view of the tank looking north from 490th Street.

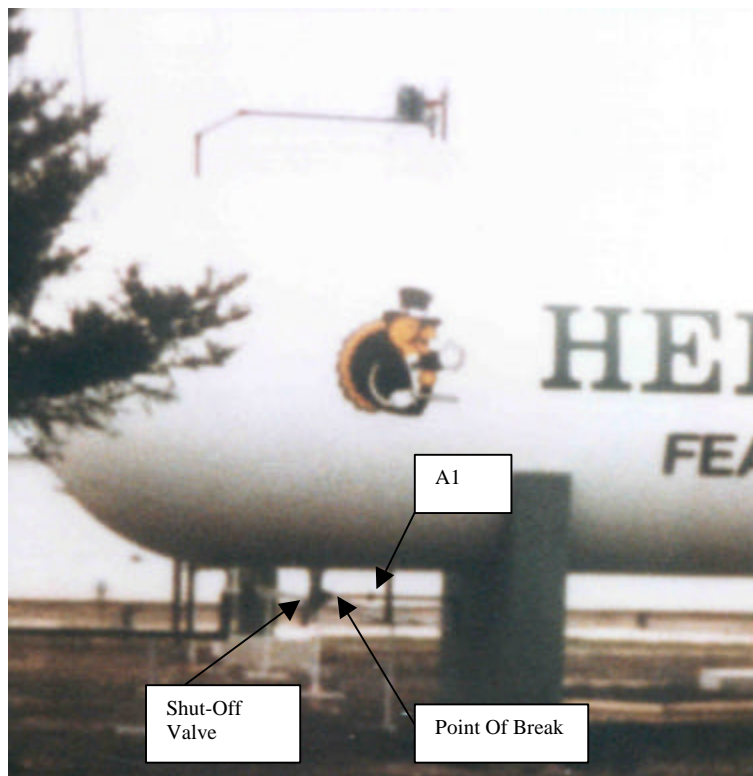
Figure 4. Liquid Line Shut-Off Valve and Point of Break

The first component in the liquid line leading to the vaporizer was a 3-inch excess flow valve. This metal valve was threaded into a 3-inch pipe coupling that was welded to the bottom shell of the tank. This excess flow valve was connected to a manual shut-off valve by a 2-inch diameter pipe (nipple) that was 2 inches in length. This metal 90°-angle valve changed the orientation of the liquid line from a downward direction to a horizontal and eastward direction. Two bushings (adapters designed to permit the joining of pipes with different diameters) connected the shut-off valve to a ¾-inch schedule 80 carbon steel pipe (outlet pipe). This outlet pipe ran to the east for approximately 30 inches toward the concrete saddle supporting the tank, and then turned downward for approximately 7 inches. This segment of pipe was subsequently labeled “A1” for evidentiary purposes (See Figure 4 below and Figure 29 in Appendix B). The outlet pipe then turned again to the north and ran to the vaporizers on a series of steel supports spaced at regular intervals. These supports placed the outlet pipe approximately 3 feet above the ground for its entire 37-foot course from the tank to the vaporizers. The arrows in Figure 4 point to liquid line components and to the approximate location of the break that occurred under the tank.

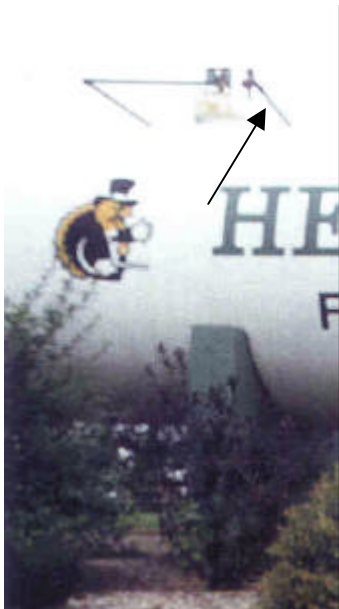
Figure 5a. Southern Exposure

The vapor line involved in this incident exited the tank vertically from a 2-inch excess flow valve screwed into the manway⁷ on top of the tank. A small segment of pipe connected this excess flow valve to a shut-off valve. This 90°-angle valve changed the course of the vapor line to a horizontal direction. The vapor line then ran northward until it extended beyond the side of the tank and then ran downward to the same elevation as the liquid line. From this point, the vapor line ran parallel to the liquid line on the same series of steel supports until both lines reached the vaporizers. Figures 5a and 5b are photographs of the west end of the tank that illustrate the vapor lines exiting the manway. The arrows point to the vapor line that ran to the vaporizers.

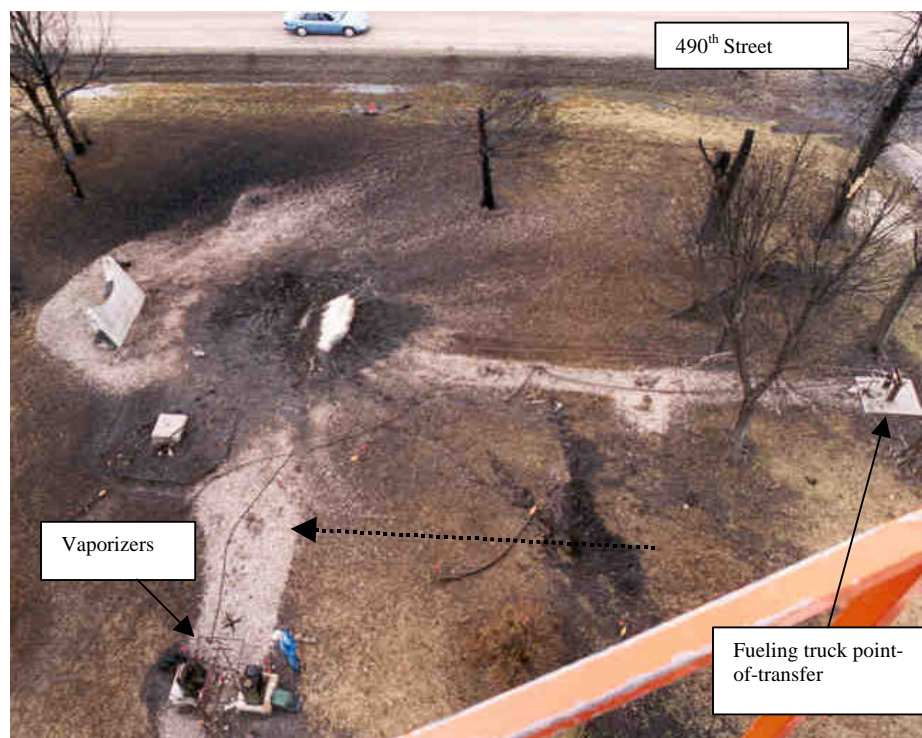
Figure 7. Aerial View of Tank Area

- 1) Parallel liquid and vapor lines used for propane supply ran to the west for approximately 40 feet. These lines terminated at the fueling truck point-of-transfer located at the edge of a gravel parking area (see Figure 2, item 8 and Figure 7). These lines were not involved in this incident.
- 2) Parallel liquid and vapor lines also ran north from the tank for approximately 37 feet to two direct-fired vaporizers⁶ (vaporizers) (see Figure 2, item 7 and Figure 7). The liquid line was located to the east of the vapor line. The ATV struck these two lines.

On cold winter days, as much as 1,000 gallons of propane were required to heat the buildings and structures on the farm. Based on this usage, fueling truck deliveries occurred as often as every week during severe winter months. When a fueling truck arrived at the farm, it parked in the gravel area located west of the propane tank (see Figure 2, item 8). The dotted arrow in Figure 7 below represents the approximate course of the ATV prior to striking the propane lines.
